RHODE ISLAND PUBLIC TRANSIT AUTHORITY

EAST SIDE TUNNEL REHABILITATION TUNNEL LINING DEMOLITION AND LANE CLOSURE INVESTIGATION

MARCH 7-9, 2022

WSP USA INC.

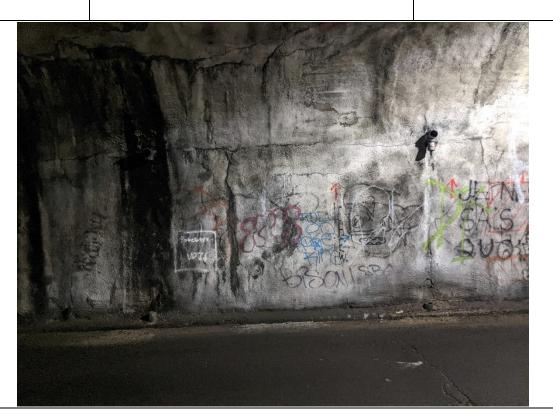
Photo No.
2Date:
3/7/22Direction Photo
Taken:
NorthwestTaken:
Voltage

Location 1 (Photos 2 to 4) was on the North Wall, approximately 4 feet above the road surface, within a larger area previously identified as hollow, and confirmed with sounding prior to any removal. Initial blows with a hand hammer removed chips of the gunite/shotcrete, which could also be scraped and/or pried off. Using a power washer was effective at removing an approximately 12"Hx12"W section of the gunite/shotcrete layer, measured to be 2" thick at this location. The gunite/shotcrete was of poor quality, exhibiting a sandy composition easily broken apart by hand. The underlying concrete was sound and strong.

Description: General view of Location 1 on North Wall prior to gunite/shotcrete demolition.

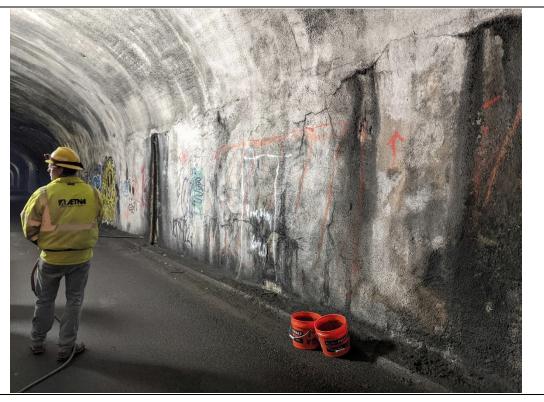
wsp		PHC	TOGRAPH LOG
Client Name RIPTA	:	Site Location: East Side Tunnel, Providence, RI	Project No. XXXXXX
Photo No. 3 Direction Ph Taken: Northwest	Date: 3/7/22		
Description: Location 1 after patch of gunite/shotcrete removed. Note depth (2") and sandy composition of material.			
Photo No. 4 Direction Ph Taken: Northeast	Date: 3/7/22		
Description: Location 1 after gunite/shotcret	er patch of

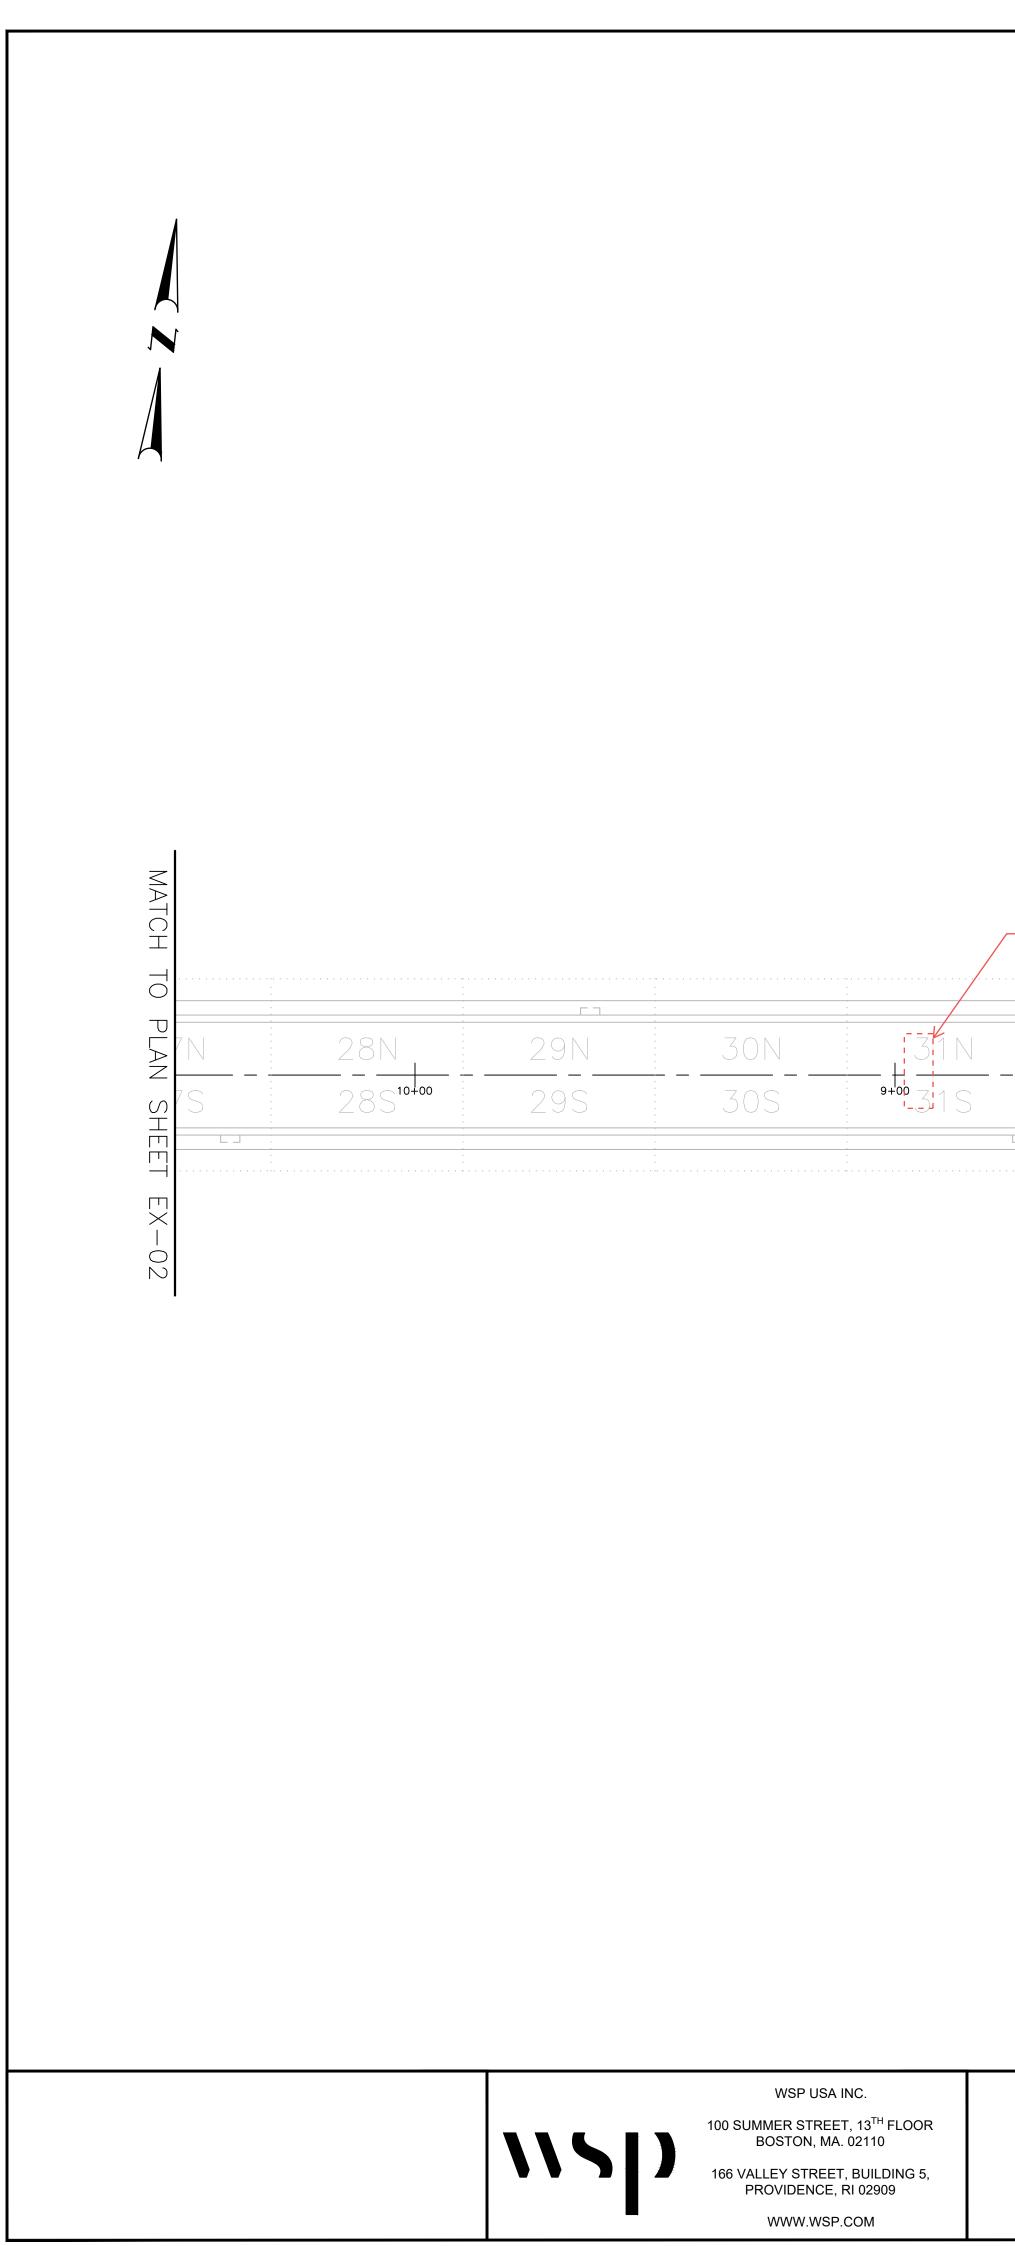
KEY PLAN N.T.S.								
Location 14 (on arch) STA 8+83 (approx)		Ň	$\frac{c}{2X-12}$ ation 13 (on arch) 7+75 (approx)	Location 12 (on arc STA 7+30 (approx)	ch)			Location 1 STA 5+85	1 (on arch) (approx) Location 10 (on a STA 5+60 (appro	ırch)	ET EX-04
32N 32S	33N		35N 35S	36N 	37N 37S	<u> </u>	38N 		40N 40S	41N 	PLAN SHE
											MATC
								2. SEE	SHEET G-03 FOR S	STRUCTURAL NOTES. EX—08 FOR DEFECTS IDEWALLS.	
RHO	DODE ISLAND PUBLIC TRANSIT AUTHORITY		RHODE ISLAND TRANSIT AUTH			SCALE: 1"=20' 10 0 5 10 GR/ REVISIONS NO. DATE B	aphic scale REVISIONS Y NO. DATE	BY PROVIDENCE		L REHABILITATION RHODE IS NNEL PLAN 3	DESIGNED BY: HP CHECKED BY: SC DATE: 04/14/20 PLAN NO.: EX-0. SHEET: 6 OF: 84
